Junkers Profly

Service Bulletin

Check of the mounting plate at the rocket tube

Issue number: TM – 001-09 – Mounting plate rocket – Revision 02

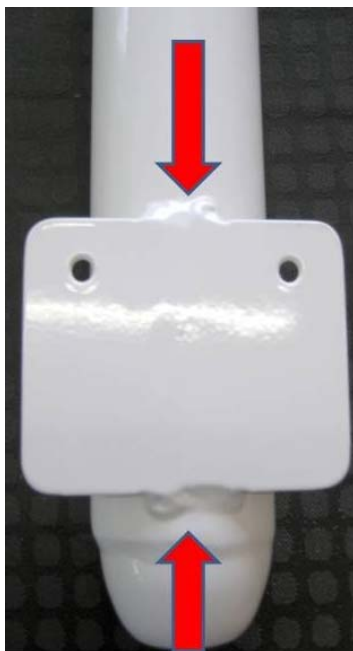
Photo 1

Reason: possible cracking at the welded connections between rocket tube and rocket mounting plate

Subject: visual check of the welded connections (s. photo 1)

Maintenance grade:	low
Qualification:	Technical expert
Repetition:	on the occasion of the yearly check
Communication:	if any cracks are found the complete rocket tube has to be sent to Junkers Profly GmbH.
